TiCu Clad[®]

Hockey Sticks

- Hockey sticks for Gravitel plants
- Safe power supply in galvanizing lines for steel strips
- Corrosion-protected, titanium-clad copper bars
- Possible repairs for corroded power connections

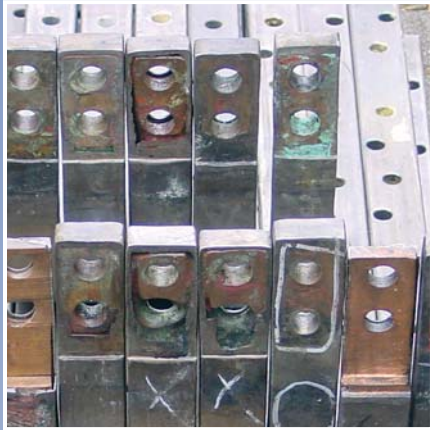
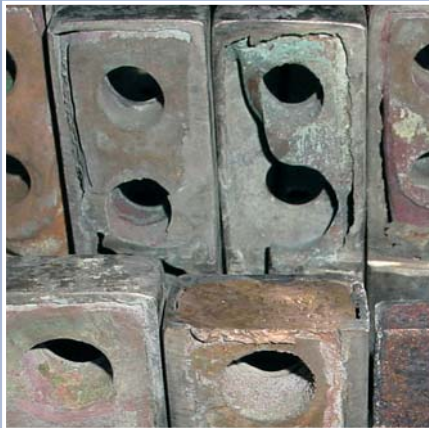
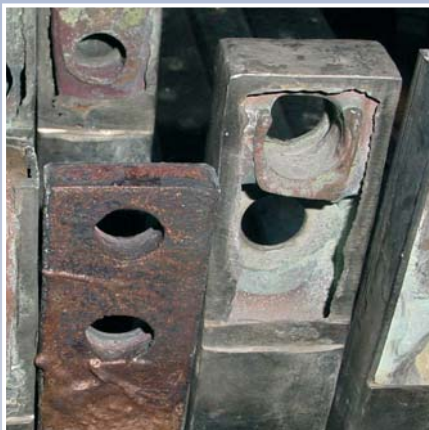
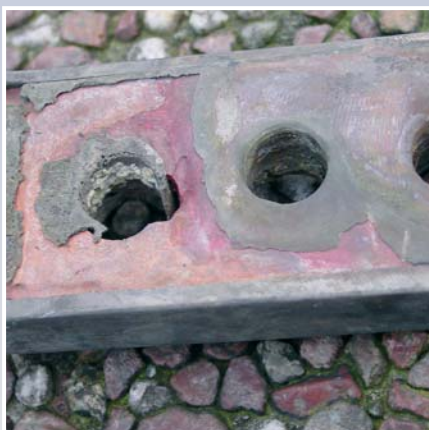
Dead and Gone.

More corrosion – less conductivity

The correct connection of titanium-clad copper bars to the power supply is a constantly recurring issue. It is widely believed that the poor conductivity titanium should be removed from the contact surfaces – usually by milling or turning:

titanium the copper contact surfaces corrode as a result of their exposure to aggressive acids, vapors and condensates in the galvanic treatment.

The copper at the contact surfaces is eaten away by corrosion. The resulting point contacts at the contact surfaces cause the electrical conductivity to deteriorate.

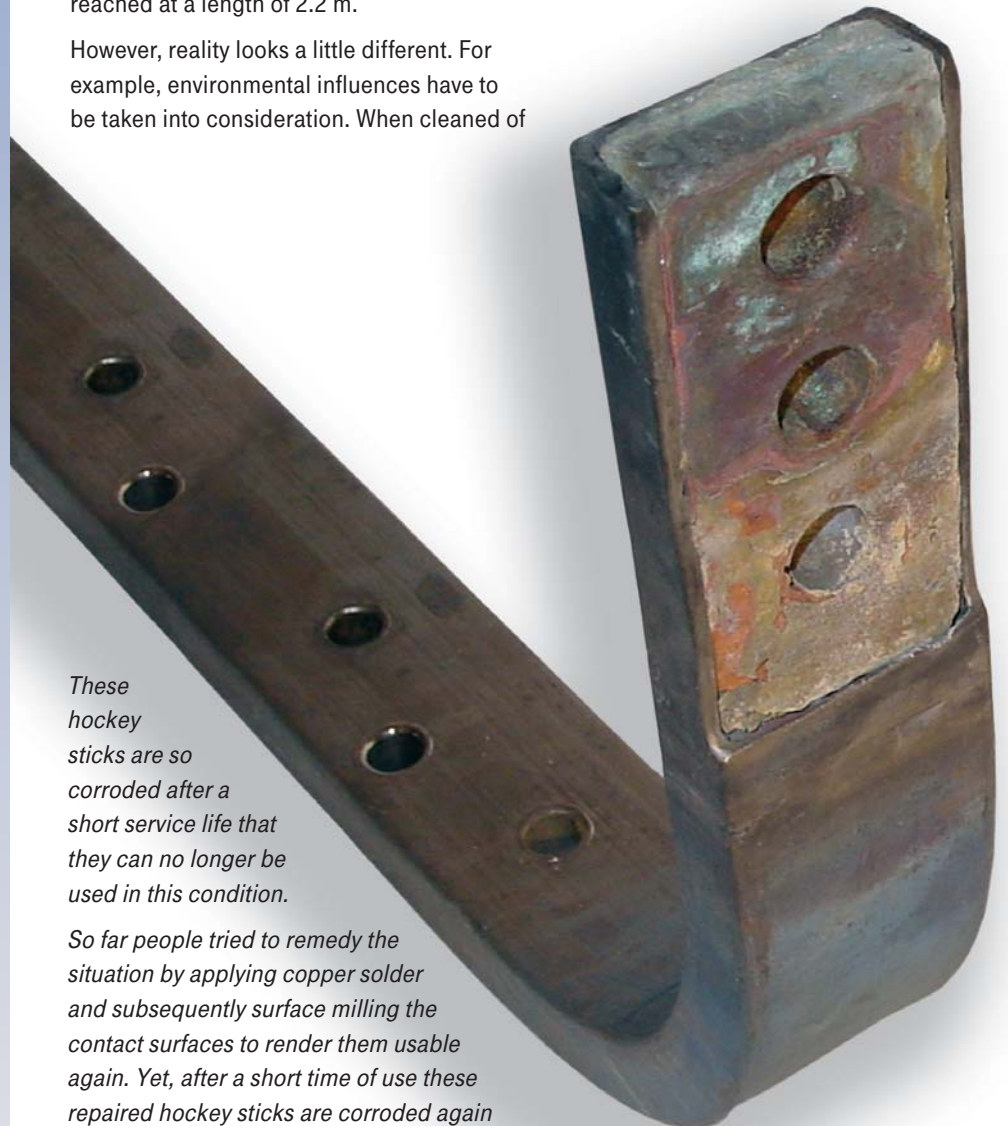
These hockey sticks are so corroded after a short service life that they can no longer be used in this condition.

So far people tried to remedy the situation by applying copper solder and subsequently surface milling the contact surfaces to render them usable again. Yet, after a short time of use these repaired hockey sticks are corroded again and depending on their condition are either repaired again or scrapped.
